Robinson, J, Frank, E, Hunter, AJ, Jermin, P & Gill, H 2018, 'The Strength of Transosseous Medial Meniscal Root Repair Using a Simple Suture Technique Is Dependent on Suture Material and Position', *The American Journal of Sports Medicine*, vol. 46, no. 4, pp. 924-932. <https://doi.org/10.1177/0363546517749807>

The strength of transosseous medial meniscus root repair using a simple suture technique is dependent upon suture material and position.

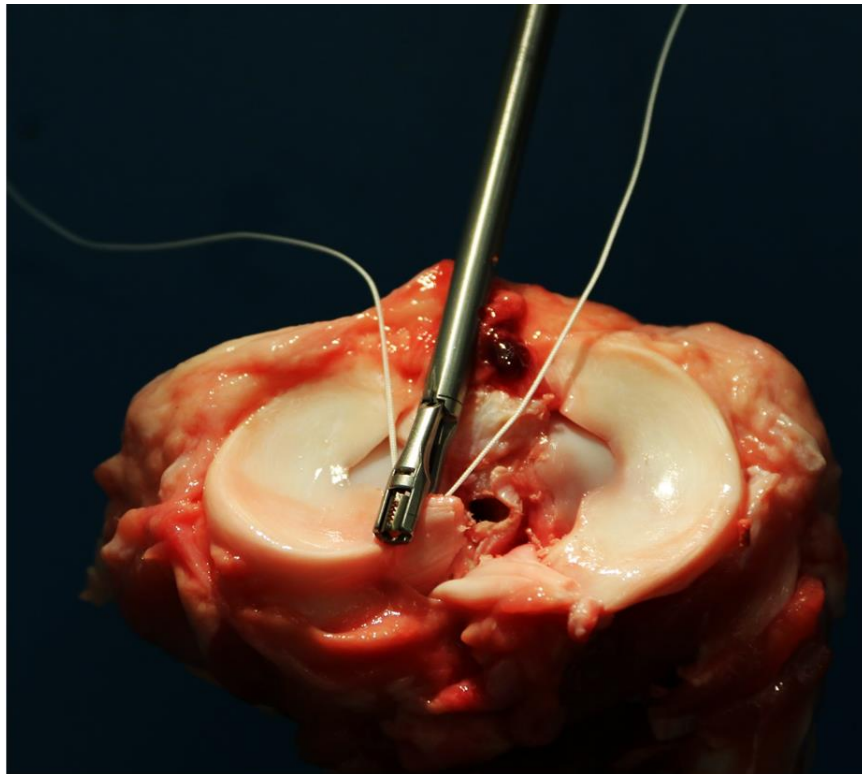
Figure 1: A suture passing device (FirstpassST, Smith and Nephew, Andover, MA), typically used in shoulder rotator cuff repair, was used to pass either No. 2 Suture (UltraBraid, Smith and Nephew Andover, MA) or 2 mm knotable tape (UltraTape, Smith and Nephew, Andover, MA) for the posterior horn root repairs. Repairs were made with either two No. 2 sutures (SUTURE) or two knotable 2 mm tapes. As per clinical surgical repair, the first suture/tape was passed into tissue of the root attachment and then shuttled down a trans-osseous tunnel drilled to the root attachment. Traction on this suture allowed the meniscus to be controlled and held more firmly allowing a second suture/tape to be passed through the meniscus medial to the first. This suture/tape was then also passed down the trans-osseous tunnel, to allow the free ends to be attached to the mandrel of the Instron tensile testing machine.

Figure 1. A suture passing device (FirstpassST, Smith and Nephew, Andover, MA), typically used in shoulder rotator cuff repair, was used to pass either No. 2 Suture (Ultrabraid, Smith and Nephew Andover, MA) or 2 mm knotable tape (UltraTape, Smith and Nephew, Andover, MA) for the posterior horn root repairs. Repairs were made with either two No. 2 sutures (SUTURE) or two knotable 2 mm tapes. As per clinical surgical repair, the first suture/tape was passed into tissue of the root attachment and then shuttled down a trans-osseous tunnel drilled to the root attachment. Traction on this suture allowed the meniscus to be controlled and held more firmly allowing a second suture/tape to be passed through the meniscus medial to the first. This suture/tape was

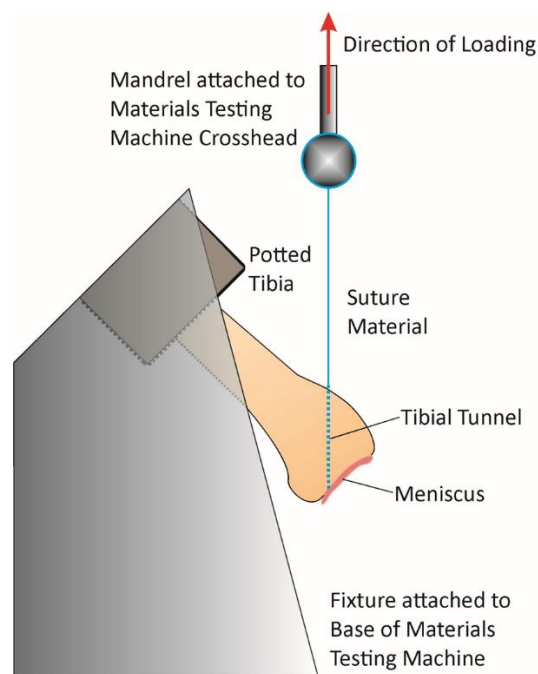
Figure 2: Experimental setup. The trans-osseous tunnel was orientated to allow the TAPE or SUTURE to be pulled parallel to the trans-osseous tunnel and to the axis of the load cell.

After surgical repair, the distal part of each tibia specimen was positioned into a custom pot using a low melting point alloy (Woods Metal 70°C, Lowden Ltd., Lower Moor, UK). Each potted tibia was then mounted inverted in a specifically designed rig that allowed adjustable positioning. The rig was secured to a material test machine (Series 5965 with 1 kN load cell, Instron, High Wycombe, UK) such that the tibial tunnel through which the sutures passed was vertically below a mandrel mounted to the crosshead (Figure 2). The sutures were securely knotted around the mandrel. Care was taken to ensure that the meniscus was repaired to its anatomical position (the meniscus was reduced back to where it had been sectioned) and that it had not been over reduced prior to testing. Each specimen was initially pre-tensioned to 2 N and then conditioned by 20 cycles¹⁶ loading from 5 to 20 N at a rate of 0.36 mm/s.⁸ After conditioning, each specimen was loaded to failure, by applying displacement at a rate of 0.5 mm/s.⁸ Load and displacement data were captured continuously at 10 Hz; the maximum failure load, as per Kim et al.¹⁵, was used as the indicator of repair strength.

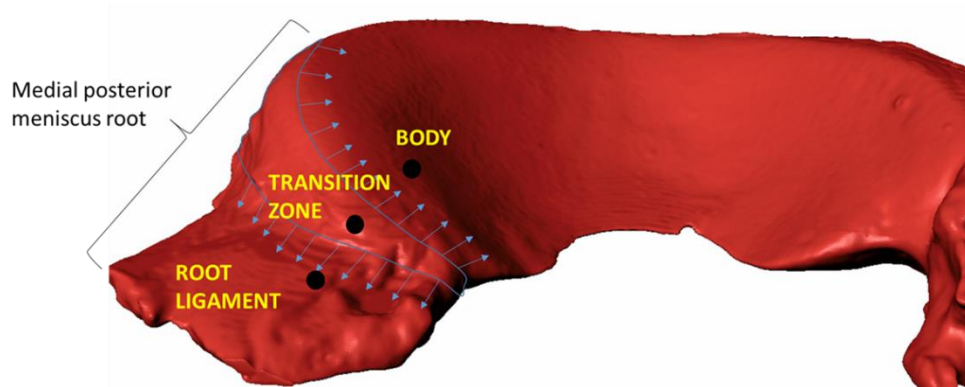
Figure 3: A 3D reconstruction from a microCT scan of a representative meniscus showing the suture/tape entry locations that were analysed.

the meniscus was important in determining the repair strength. In Part B menisci were scanned using a microCT scanner (Nikon X-Tek, XT H 225 ST, Shinagawa, Japan). The reconstructed scan data were used to establish the suture locations. The mode of failure from the mechanical testing was, in all specimens, by the sutures cutting out of the meniscus lateral to the 0.9 mm hole made by the suture passing device. The entry point into the meniscus of the most posteromedial suture (this was the second suture inserted) was classified as being in the: i) Root Ligament [RL], ii) Transition Zone [TZ] or iii) the substance of the meniscus [BODY] (Figure 3). Entry point classification was performed blinded (EGF) to the Instron data. The ICC for repeated blinded evaluation within an examiner was 0.98 (95%CI 0.95 to 0.99).

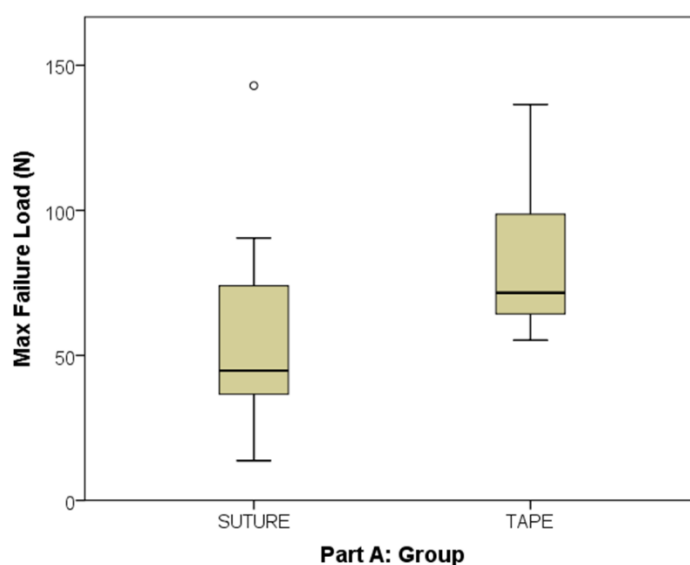
Figure 4: Maximum failure load for Part A, SUTURE ($n=10$) versus TAPE ($n=9$) groups. The circle represents an outlier greater than the third quartile (Q3) + 1.5 times the interquartile range).

During the cyclic loading performed to condition the specimens, the average displacement was 1.65 mm (95% CI 1.39 to 1.91 mm); there was no difference between the TAPE and SUTURE material in the displacement during conditioning ($p=0.756$, Mann-Whitney U). The maximum failure load for the repairs made using the TAPE material was approximately 52% greater than that for the SUTURE material (Figure 4), this was significant ($p=0.043$, Mann-Whitney U). Considerable variability in maximum failure load was observed (Figure 4), the range was from 55.3 to 136.5 N for the TAPE group and from 13.7 to 143.0 N for the SUTURE group.

Figure 4: Maximum failure load for Part A, SUTURE (n=10) versus TAPE (n=9) groups. The circle represents an outlier greater than the third quartile (Q3) + 1.5 times the interquartile range).

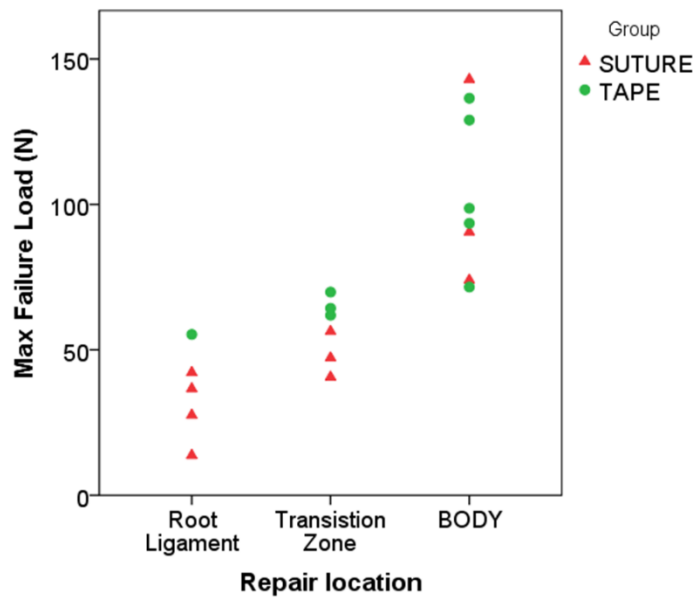
Figure 5: Effect of suture/tape entry location on maximum failure load for Part A.

The 3D analysis showed that the distribution of entry point locations was not even between the SUTURE and TAPE groups, with four of the SUTURE group having RL entry points compared to one for the TAPE group; additionally, only three of the SUTURE group had BODY entry points compared to five of the TAPE group. For the whole group of Part A specimens, the maximum failure load was significantly different ($p=0.001$, Kruskal-Wallis) between the entry point location groups (Figure 5). Maximum failure load was highest for the BODY location, 104 N (95% CI 81.2 to 128.0 N), and lowest for the RL location 35.1 N (95% CI 15.7 to 54.5 N).

Figure 5: Effect of suture/tape entry location on maximum failure load for Part A.

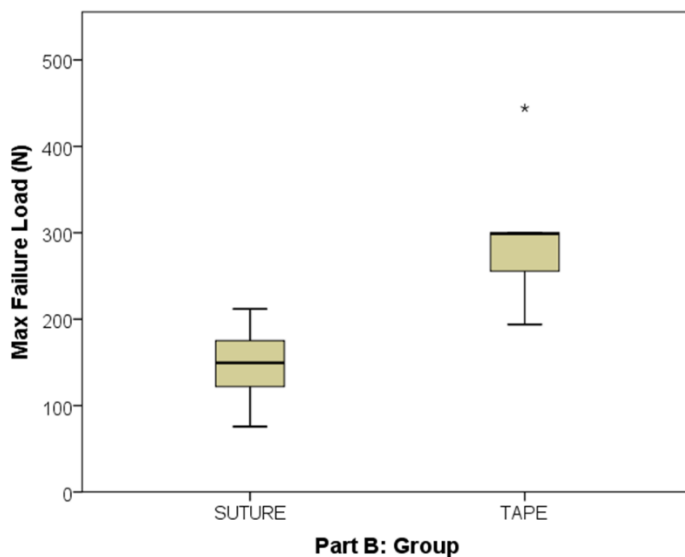
Figure 6: Maximum failure load for Part B, SUTURE ($n=5$) versus TAPE ($n=5$) groups. The asterix represents an extreme outlier value (three times the inter quartile range from either the first quartile [Q1] or the third quartile [Q3]).

The 3D reconstructions confirmed that all second suture entry points for all specimens in Part B were located at the BODY location. The maximum failure load values for both repair material groups were substantially higher than had been observed for Part A. The maximum failure load was significantly ($p=0.016$, Mann-Whitney U) greater for the TAPE group, approximately double, compared to that for the SUTURE group (Figure 6).

Figure 6: Maximum failure load for Part B, SUTURE (n=5) versus TAPE (n=5) groups. The asterix represents an extreme outlier value (three times the inter quartile range from either the first quartile [Q1] or the third quartile [Q3]).

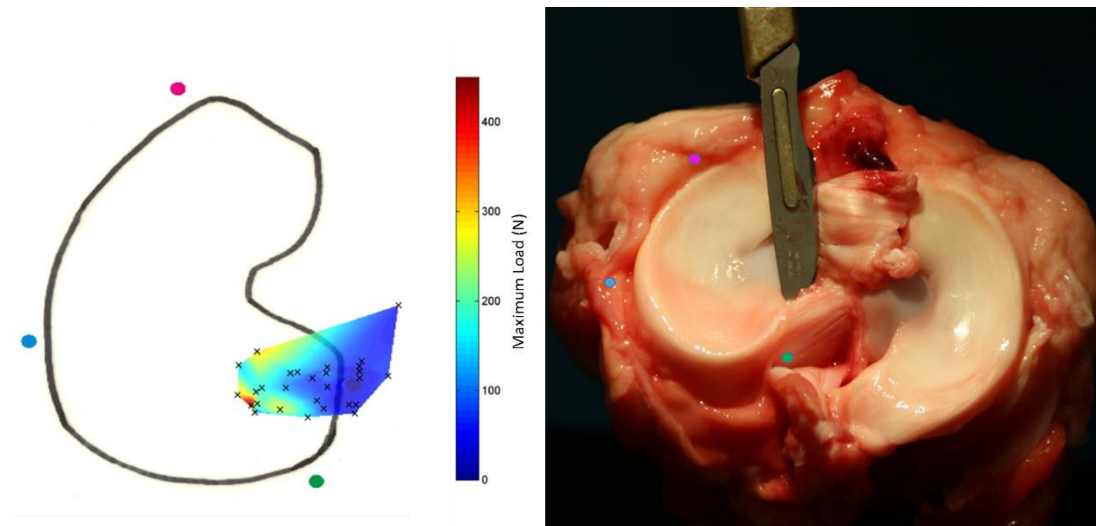
Figure 7: Heat map of maximum failure load as a function of suture/tape entry location (points shown as crosses) generated from all 29 specimens based on image registration and warping to a representative meniscus; the image on the right shows a photograph of the tibial plateau to allow orientation of the heat map. For initial registration coloured dots were placed in the most anterior (magenta), posterior (green) and medial (cyan) aspects of each meniscus; the image of the tibial plateau on the right has the same locations marked to clarify position of heat map. The heat map was generated based on cubic interpolation. Small variations in suture insertion point were found to result in a large difference in maximum failure load. Highest failure loads were found for insertion points within the substance of the body of the meniscus to either side of the central part of the transition zone.

The registration procedure was able to successfully register all specimens to the reference specimen. The mapping between suture insertion point and maximum failure load indicated that small variations in suture insertion point could result in a relatively large reduction in failure strength (Figure 7). Highest maximum failure loads were found for insertion points within the body of the meniscus to either side of the central part of the transition zone.

The heat map generated from the image analysis (Figure 7) shows the sensitivity of failure load to small variations in suture insertion point. Of note the strongest repairs were found to occur on either side of the main transition zone. The collagen fibres in the root ligament are mostly orientated parallel to the direction of the root ligament, and this parallel fibre orientation continues into the body of the meniscus.³² Repairs located within the transition zone where the fibres are predominately parallel have approximately half the strength of those outside this area. The gradient of maximum failure load is very steep in the latero-posterior portion of the medial meniscal root adjacent to the transition zone. Polarized light microscopy⁶ and optical projection tomography² of the meniscus has shown that the principal orientation of the collagen fibres in the substance of the meniscus is circumferential. In the outer third of the meniscus the circumferential collagen fibres are organised in fascicles. These are parallel to the fibres in the transition zone and root ligament

Figure 7: Heat map of maximum failure load as a function of suture/tape entry location (points shown as crosses) generated from all 29 specimens based on image registration and warping to a representative meniscus; the image on the right shows a photograph of the tibial plateau to allow orientation of the heat map. For initial registration coloured dots were placed in the most anterior (magenta), posterior (green) and medial (cyan) aspects of each meniscus; the image of the tibial plateau on the right has the same locations marked to clarify position of heat map. The heat map was generated based on cubic interpolation. Small variations in suture insertion point were found to result in a large difference in maximum failure load. Highest failure loads were found for insertion points within the substance of the body of the meniscus to either side of the central part of the transition zone.
